Sealing Connections

IP66 and High Pressure Wash Down tests were conducted to demonstrate the ability of O'Brien self-bonding silicone rubber tape to seal the jacket and tube as well as the transition to compression fittings.

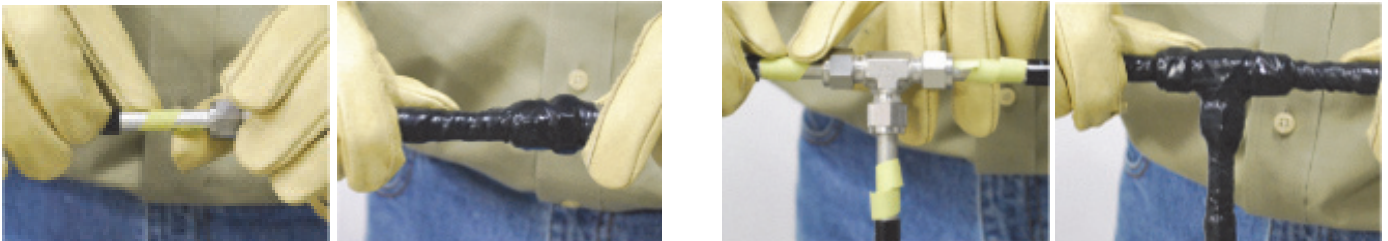
O'Brien TPKJP-SR-B self bonding silicone sealing tape creates a cross-linked bond between layers when applied. Since it does not rely on a secondary adhesive aging only increases the bonding mechanism.

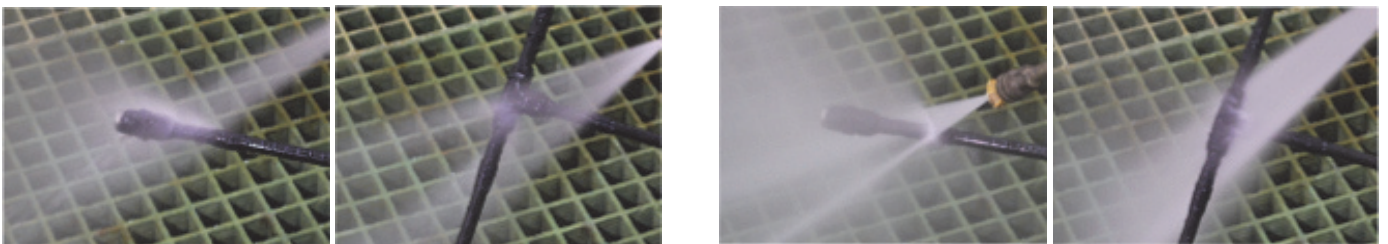
IP66 testing uses deluge of a high volume low pressure spray directed at the sample from a maximum distance of 2.5 – 3M.

The more severe High Pressure Wash Down test uses a low volume spray at high pressure at close distances, 100 – 150 mm.

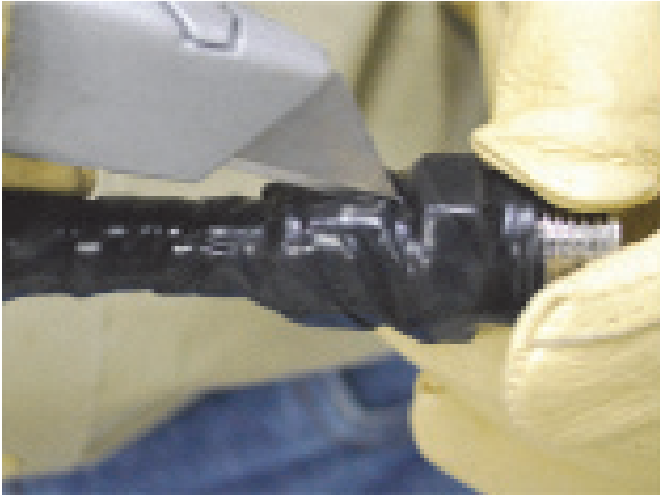
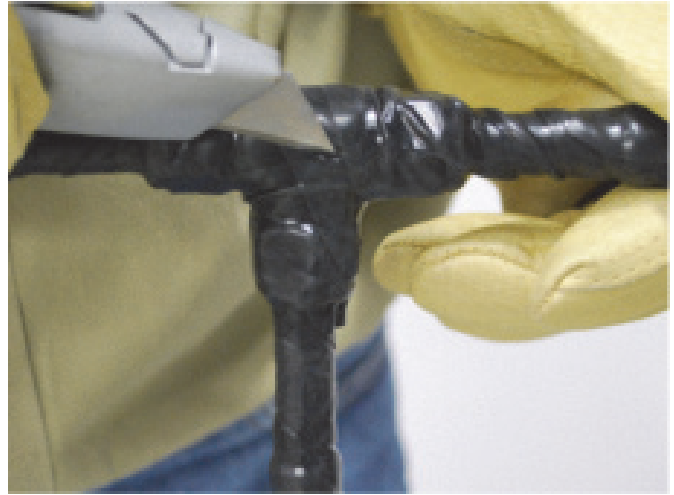
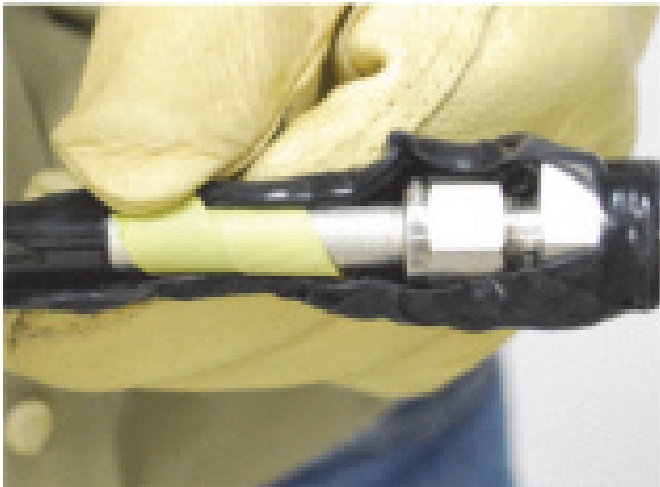
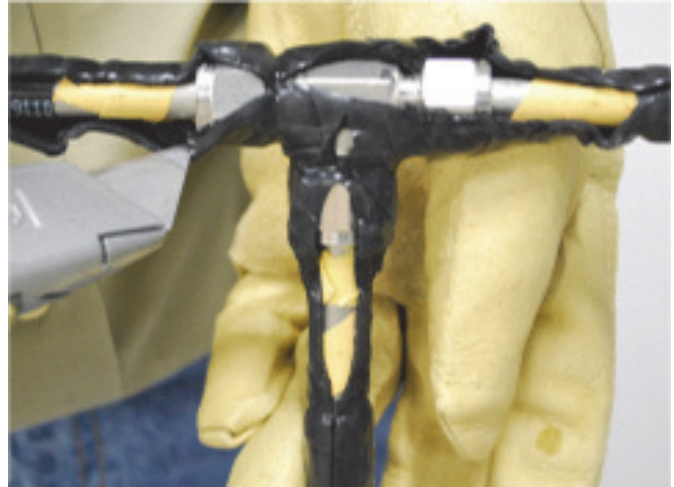
Surface was dried and seal was cut open. Litmus paper remained unchanged. This indicates that no moisture penetrated the self-bonding silicone sealing tape (TPKJP-SR-B) after both IP 66 and high-pressure wash down exposure

Findings: Upon conclusion the self-bonding seal exhibited only minor scuffing of the surface. No tearing or separation was found. No water ingress was detected.

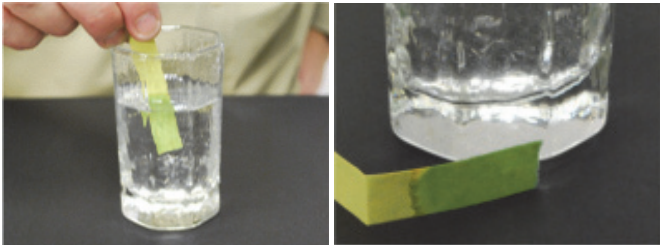
Hygroscopic litmus paper positively identifies the presence of moisture.

Test Description: O'Brien self-bonding silicone sealing tape (TPKJP-SR-B) was applied over a compression fitting installed on a TAW05589 polymer coated single 3/8" SS tube (TPJ1U-B3) per the recommended installation procedure. In order to detect any leakage or penetration of water, litmus paper was wrapped around the bare tube under the self-bonding sealant.
