Weld tests were conducted to demonstrate the ability of O'Brien TAW05589 jacketed single tube and multiple tube bundles to protect the tube from weld slag corrosion.

TAW05589 Protection

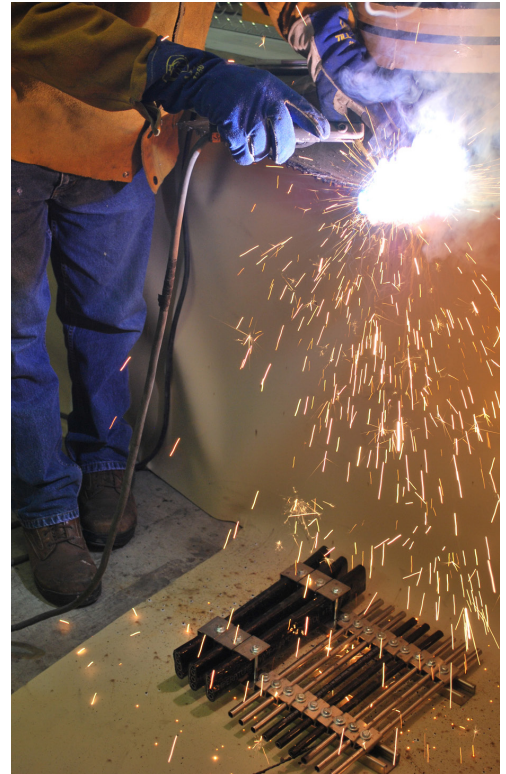
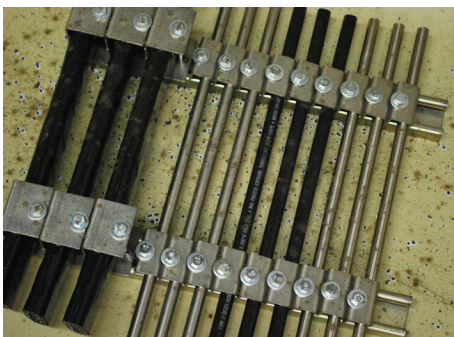
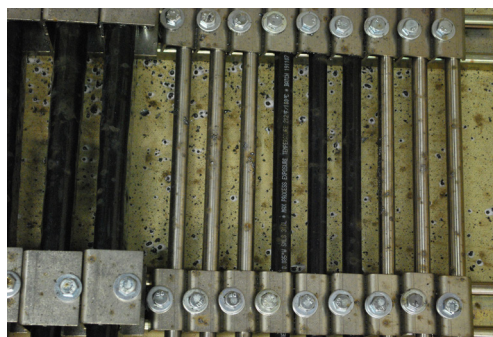
Weld slag was created using a 240V electric arc welder at 240 amps and cutting chamfer rod on a 10ga carbon steel panel suspended 80 - 85mm above the test specimens. The line of weld slag created was perpendicular to and roughly centered over the test specimens. Slag and stringers from the cutting action were allowed to freely distribute over the test specimens.

Findings: O'Brien TAW05589 jacketed tubing exhibited only minor discoloration to the jacket surface even where stringers had become lodged between samples. No penetration or pitting marks were observed. The unprotected bare 316L/UNS S31603 and 2507/UNS S32750 tubing had weld slag adhered to the surface of the tube that was not removed with light scraping.

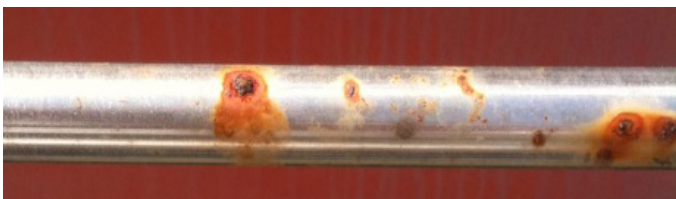
Corrosion from weld slag on 316L/UNS S31603 SS.

The test rack was exposed to ambient conditions in Houston, TX and examined after three months. All unprotected bare 316L/UNS S31603 and 2507/UNS S32750 tubing exhibited surface corrosion in the areas where the weld slag was adhered.

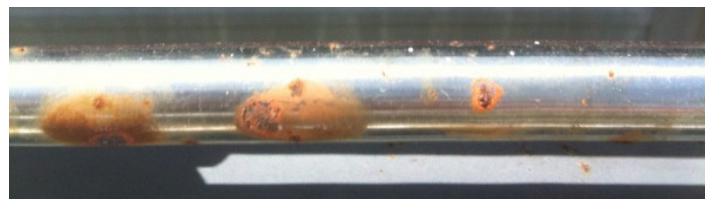
Corrosion from weld slag on 2507/UNS S32750 Super Duplex.
